Technical Bulletin

REF: PIL 031

Technical procedure to install new Bolt Socket Head (Meritor part number 41X1692)

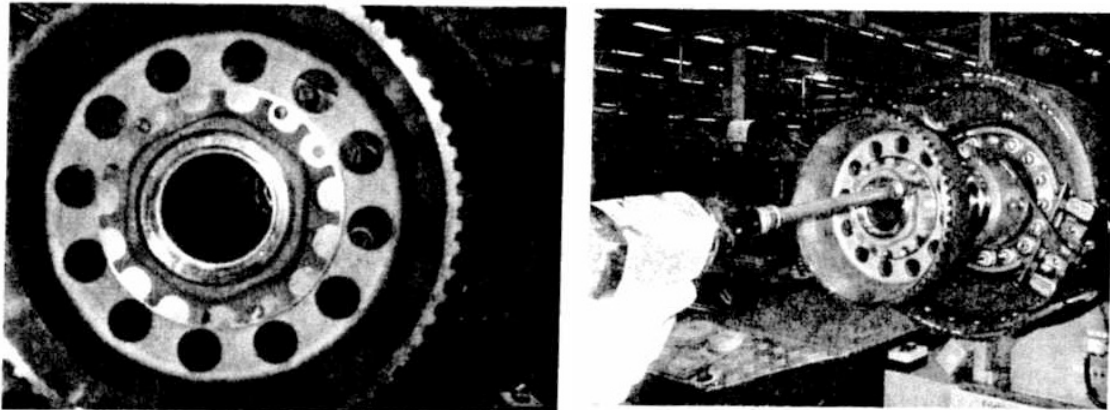
Please observe, due to incompatibility between new and old locking systems:

Old Ring Gear Carrier (Meritor part number 3204J1076) must be serviced with new Ring Gear Carrier (Meritor part number 3204W1089) and new Bolt Socket Head (Meritor part number 41X1692)

The old Ring Gear Carrier (Meritor part number 3204J1076) is not compatible with new Bolt Socket Head (Meritor part number 41X1692)

1. Assemble Ring Gear Carrier (Meritor part number 3204W1089) according to normal procedure.
2. Torque Hub Nut according as to current specifications.
3. The slots in the Hub Nut flange, independently of position, always accommodate the best fit for the Bolt Socket Head. Observe the best fit, where the socket of the bolt will fully fit within the slot of the hub nut, and proceed with the assembly procedure. (Note: Do Not assemble the Bolt Socket Head on top of Hub Nut flange surface.)
4. Torque the Bolt Socket Head with 45Nm +/- 5Nm
5. Continue the assembly according to normal procedure.
