TP-9789

# **Carriers and Transmission Core Inspection Deduction Examples**Revised 3/2019

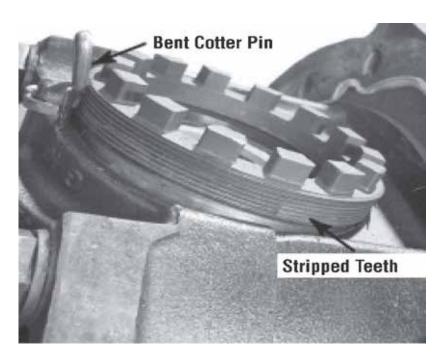
### **Blown/Pushed Out Adjusting Ring**

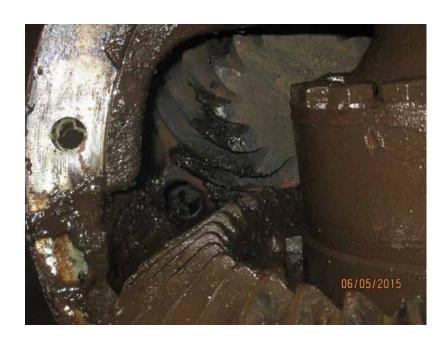
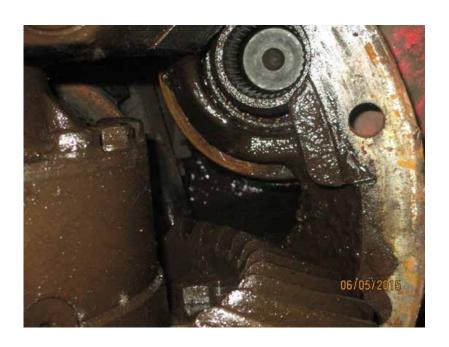
# Burn Up (Low Lube Failure)

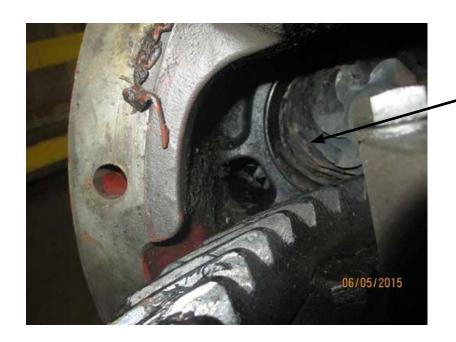
Excess build-up of grease just to the left of the pinion gear. The pinion gear has melted. Grease is on the ring itself and pinion bearing is not intact.

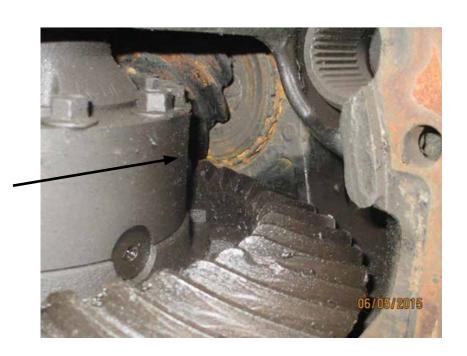
Excess build-up of grease on the ring gear, a melted pinion gear. The inner pinion bearing shows what a burned bearing looks like.
