# EX+™ DRIVER PRE-TRIP INSPECTION

**MERITOR**

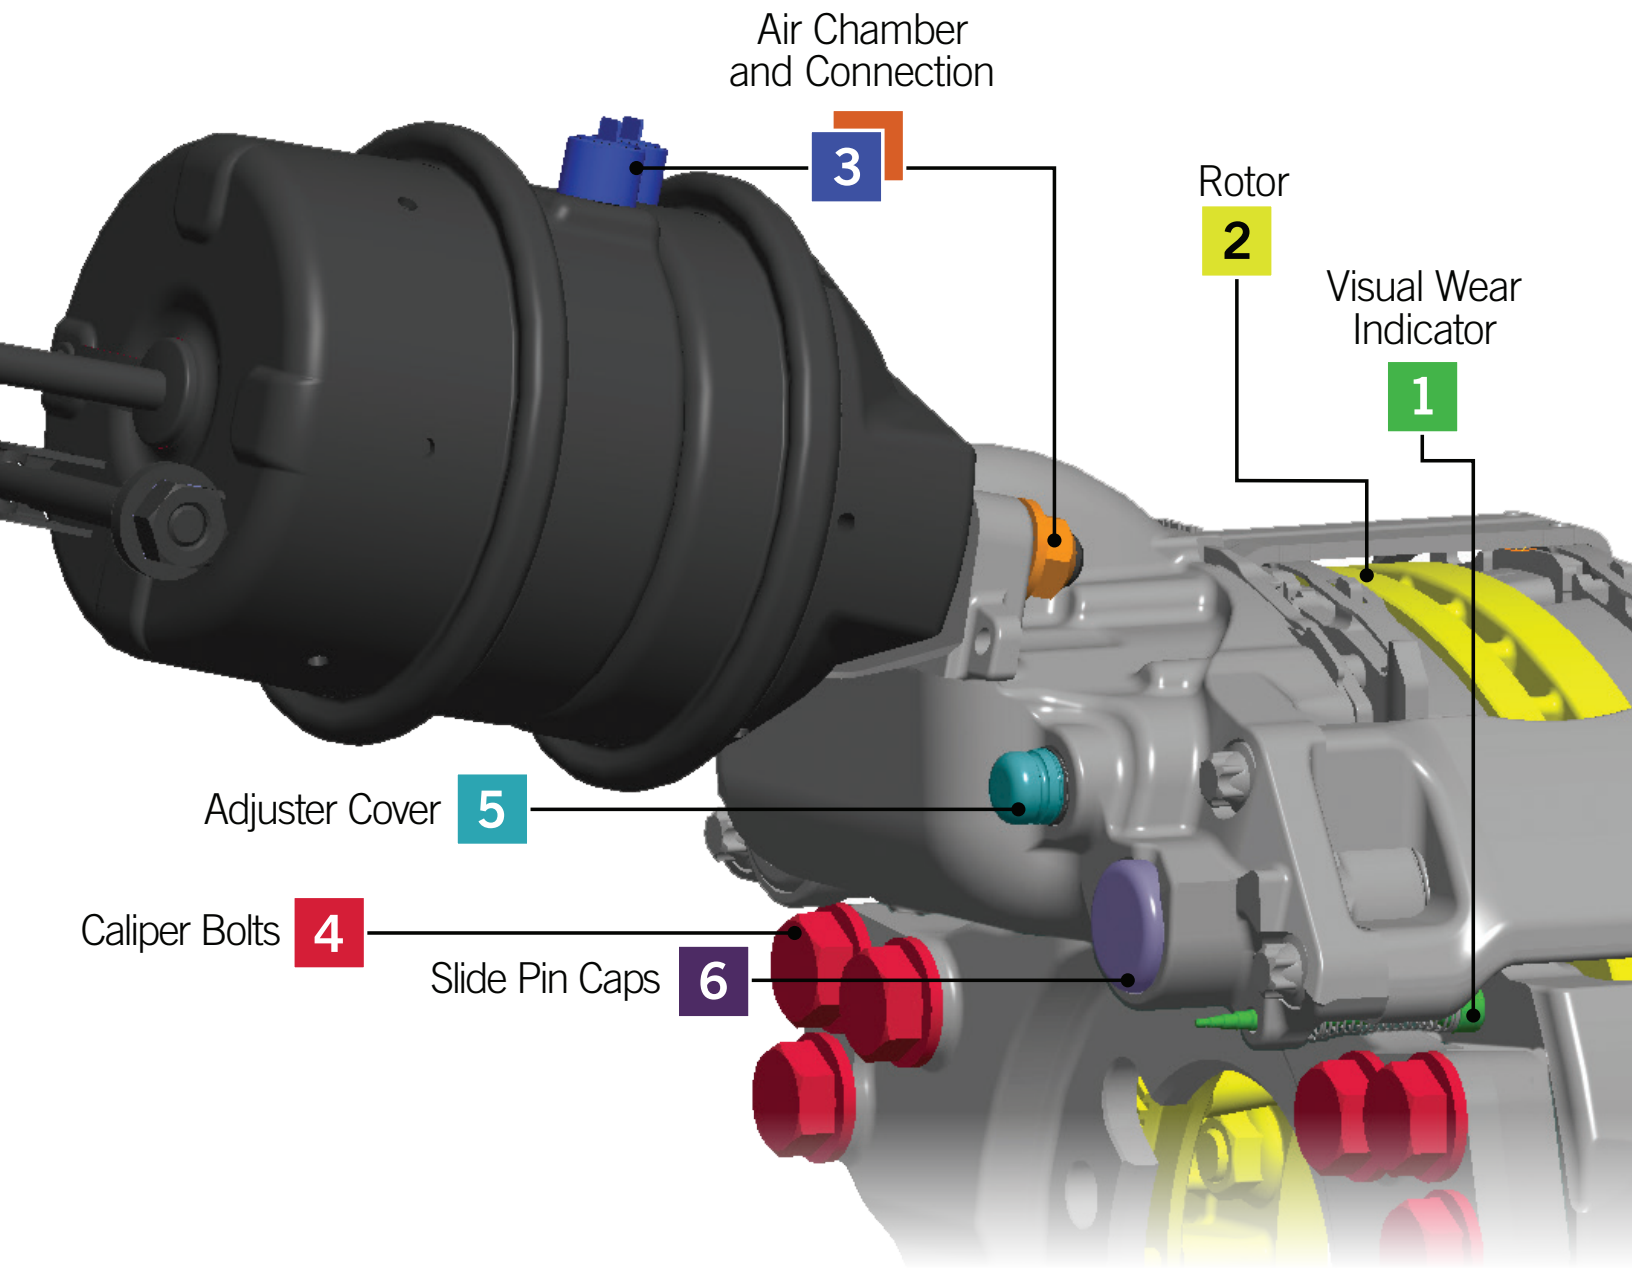
Air Chamber  
and Connection

3

Rotor  
2

Visual Wear  
Indicator  
1

Adjuster Cover 5

Caliper Bolts 4

Slide Pin Caps 6

Visually inspect the rotor for signs of cracks, deep grooves, blue marks and heat checking.

Inspect the air chamber to verify that the air chamber-to-caliper mounting nuts and air lines are securely fastened and are not damaged.

Visually inspect the caliper mounting bolts and ensure all 6 bolts are present.

Visually inspect for caliper adjuster cover. If missing, replace with new cover.

Visually inspect the slide pin caps, if missing, further inspection of the slide pins and bushings is needed.

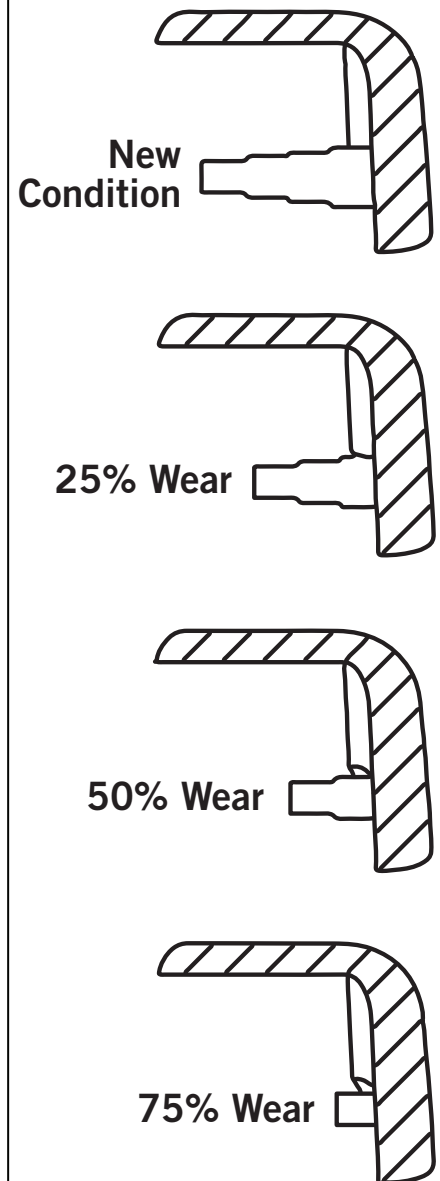
**Figure 1**

If the indicator shows more than 75% wear, perform wheels-off inspection. (Figure 1)
