### Installing Brake Shoes Equipped with Lining Wear Sensors

All Meritor Q Plus™, Q and P Series Cam  
Brakes Equipped with Lining Wear Sensors

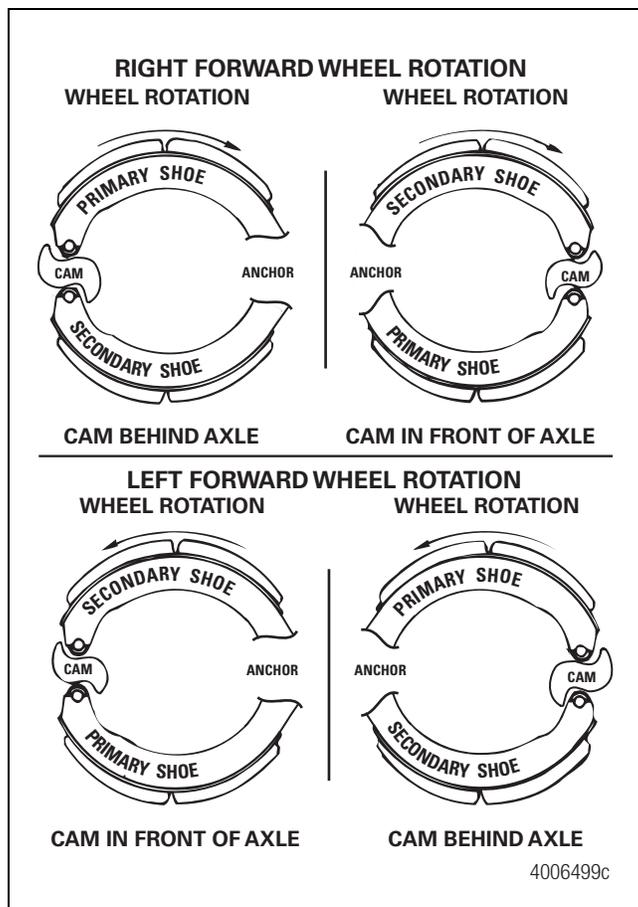
Figure 1

The brake shoe assembly includes a lining wear sensor. The sensor is located in the primary shoe lining block closest to the camshaft on the inboard side. The first shoe past the camshaft in the direction of wheel rotation is the primary shoe.

The primary shoe can either be on the top or the bottom position, depending on the location of the cam. If the cam is behind the axle, the top shoe is the primary shoe. If the cam is in front of the axle, the bottom shoe is the primary shoe. Figure 1.

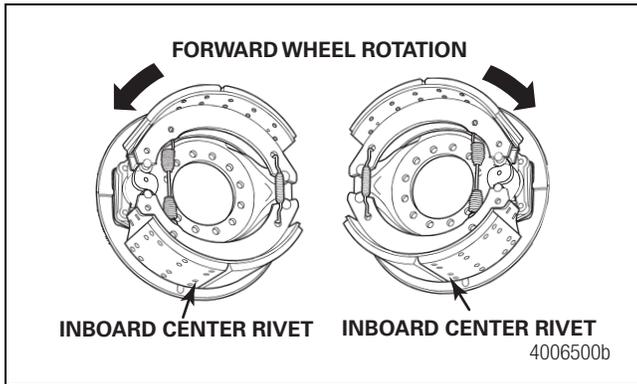
**Figure 2**

The preferred sensor position is the primary shoe, cam end block, inboard center rivet. Figure 2.
