Service Parts Instructions

Trailing Arm Bushing Removal and Installation Procedures for All RideStar™ RFS Series Trailer Air Suspension Systems

Kit 11201 (RFS23T)

Kit 11205 (RFS25T)

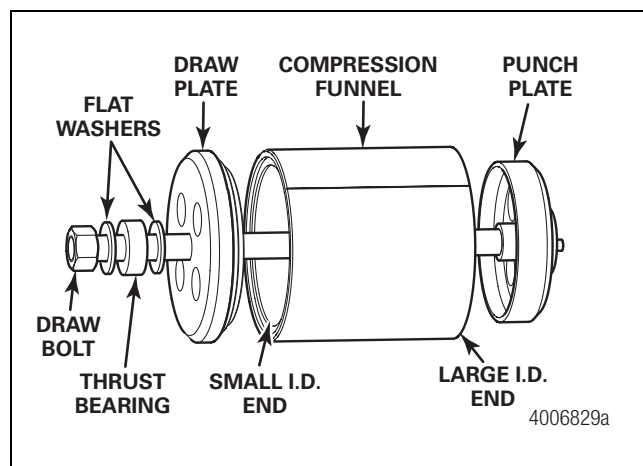
Figure 1

The bushing replacement procedure requires a special bushing tool, part number A-3256-R-1188. Figure 1.

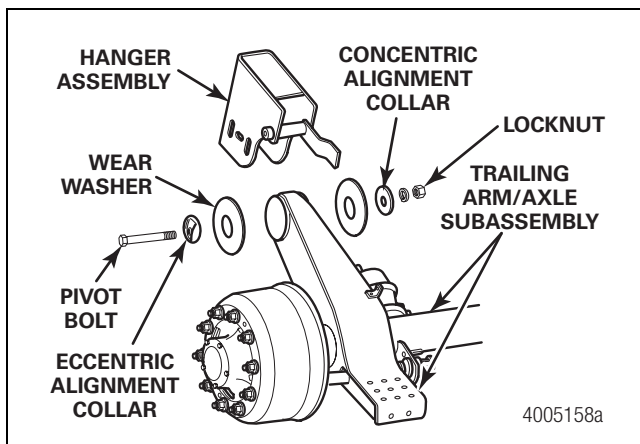
Figure 2

1. Wear safe eye protection.
2. Park the vehicle on a level surface. Block the wheels to prevent the vehicle from moving.
3. Use an appropriate lifting device to raise the trailer frame so that the suspension is above the specified ride height. Refer to Maintenance Manual 14F to determine the correct ride height. Support the rear of the trailer with safety stands.
4. Exhaust all air from the suspension system by unseating the valve at the bottom of the air tank.
5. Support the trailing arm and axle subassembly with safety stands.
6. Remove the locknut and inner concentric alignment collar from the pivot bolt at both hanger assemblies. Figure 2. Carefully remove the pivot bolts and outer alignment collars from both sides.

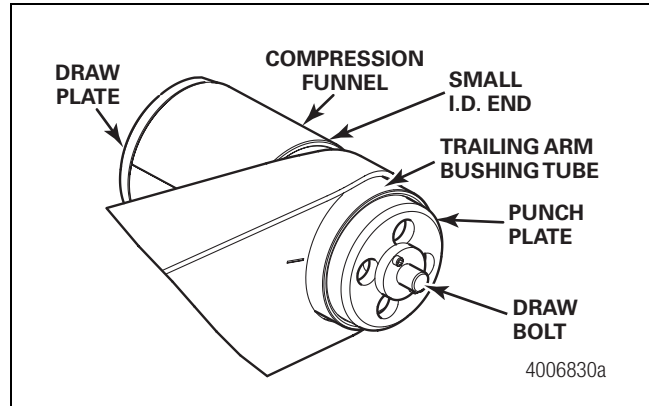
Figure 3

7. Lower the trailing arm and axle subassembly down and out of the hangers. Discard the locknuts, pivot bolts, wear washers and alignment collars.
8. Apply a small amount of lubricant around the radius of the bushing with the bushing still in the tube. Meritor recommends using a mild non-petroleum-base dish soap.
9. Apply a light coat of lubricant to the inside diameter of the compression funnel. Place the smaller end of the compression funnel onto the trailing arm bushing tube. Figure 3.

10. Place the draw plate onto the large I.D. end of the compression funnel opposite of the trailing arm bushing tube.
11. Insert the draw bolt, flat washers and thrust bearing through the draw plate and the multi-functional bushing. Figure 3.
12. Thread the punch plate onto the draw bolt until it rests against the bushing to be removed. Figure 3.
13. Snug the draw bolt while ensuring that the compression funnel rests securely against the trailing arm bushing tube. Figure 4. The thrust bearing must be free to turn at all times. Meritor recommends lubricating the draw bolt threads and between the thrust bearing and flat washers with bearing grease such as Shell Darina Grease 1 or equivalent, before each bushing replacement.

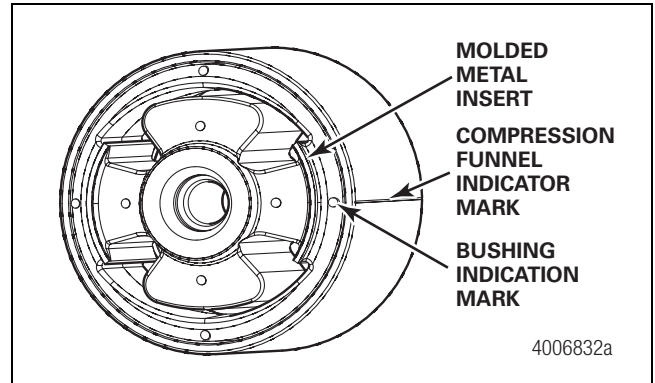
Figure 5

4. Insert the multi-functional bushing into the large I.D. end of the compression funnel. Verify that the bushing mark is aligned with the compression funnel indicator line. Use the bushing indicator mark adjacent to the molded metal insert. Figure 5.

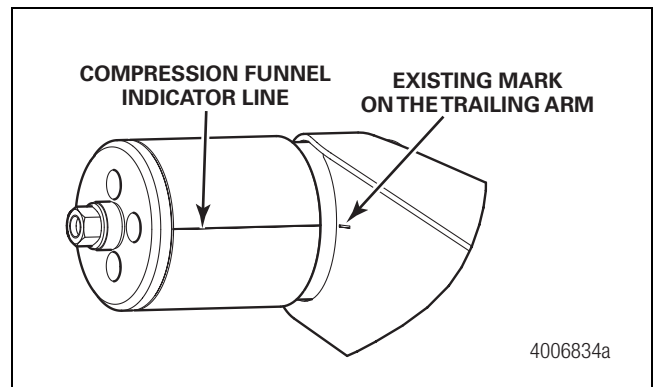
Figure 6

5. Place the draw plate onto the inside surface of the trailing arm bushing tube.
6. Insert the draw bolt, flat washers and thrust bearing through the draw plate and trailing arm bushing tube.
7. Place the small end of the compression funnel with the bushing over the draw bolt and onto the trailing arm bushing tube. Align the indicator mark on the compression funnel with the existing mark on the trailing arm. Figure 6.

9. Verify that the indicator line on the compression funnel lines up with the existing mark on the trailing arm. Figure 6.
10. Snug the draw bolt while ensuring that the compression funnel and draw plate rest securely against the trailing arm bushing tube. The thrust bearing must be free to turn at all times.

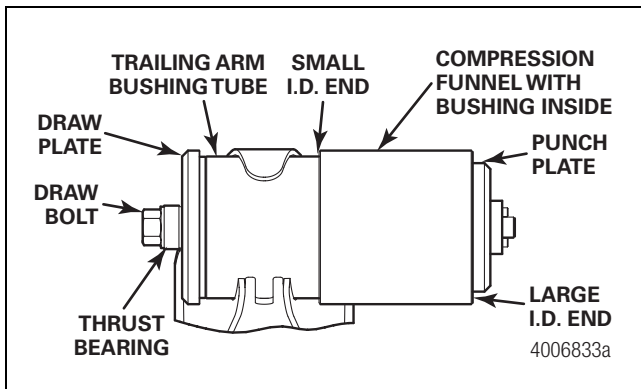
Figure 7

8. Thread the punch plate onto the draw bolt until it rests against the bushing inside the compression funnel. Figure 7.

11. Turn the draw bolt CLOCKWISE using a 1/2-inch impact wrench at a reduced and steady speed to draw the bushing into the trailing arm bushing tube. Figure 7.
12. Support the compression funnel as it disengages from the bushing tube so it does not fall. The compression funnel will fall away before the bushing is completely seated inside the bushing tube.
13. Continue rotating the draw bolt until the bolt stops turning. Do not overtighten the bolt.
 - **If the bolt stops turning or extreme resistance is present:** Reverse the impact wrench and loosen the tool assembly. Inspect all components of the tool kit for damage. Reset the draw plate ensuring that the compression funnel is correctly seated against the trailing arm bushing tube. Try to tighten the bolt again.

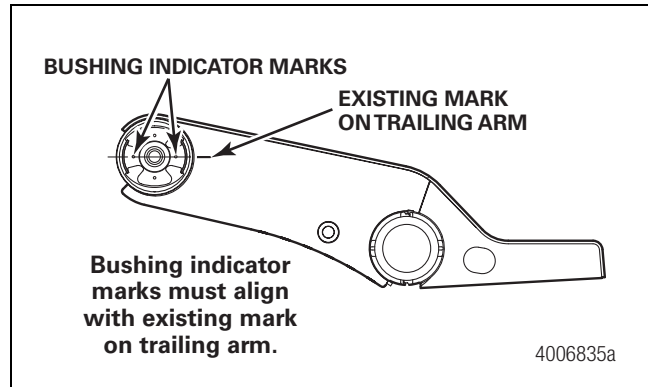
Figure 8

14. Verify that the bushing indicator mark is aligned with the existing mark on the trailing arm. Figure 8.
