SELF-ADJUST CLUTCH INSTALLATION GUIDE

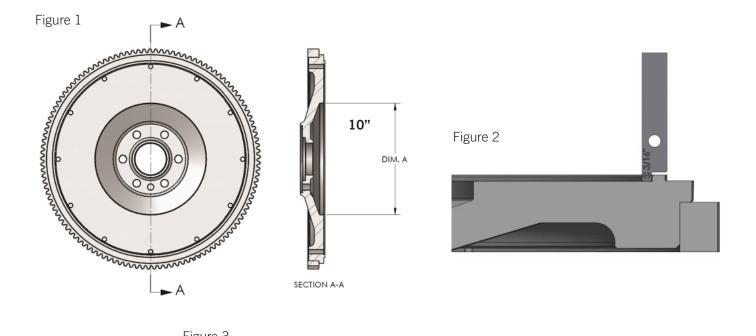
Verify Correct Flywheel Dimensions Flywheel bore (DIM A) must be a minimum of 10". (See Figure 1)

You must have a minimum of 5/16" distance from the friction surface (face) of your flywheel to the top of the bolt head that holds the flywheel to the crankshaft. If it is less than 5/16", you need a NEW flywheel! (See Figure 3)

Flywheel clutch pilot cannot be greater than 3/16" deep. If it is greater than 3/16" the clutch will not bolt tight to flywheel. (See Figure 2)

- 1. Resurface or replace flywheel. Surface must be smooth or premature clutch failure can occur. REMEMBER: Machining the flywheel past the recommended .060" moves the pressure plate away from the transmission. In this event, install a fiber spacer (provided) on the input shaft between the clutch brake and the transmission. The release yoke in the bell housing may not align properly with the pressure plate release bearing housing. Linkage adjustment may be required during clutch set-up. If resurfacing is required, while the flywheel is mounted to the crank shaft, verify correct flywheel dimensions as seen in Figure 2 and Figure 3.

- 4. Verify disc fits in flywheel bore (Figure 1). Slide disc the length of the input shaft checking for twist and wear. Insert alignment shaft through bearing housing. Install rear disc (oriented correctly), center plate, and front disc (oriented correctly) on alignment shaft. Move clutch housing towards flywheel making sure cover fits into flywheel pilot.

- Disc in backwards
- 5/16" flywheel dimension is too small and disc is hitting crank bolts (See Figure 3)
- Flywheel bore is smaller than 10" (See Figure 1)

- Flywheel not resurfaced
- Flywheel Clutch Pilot is less than 3/16" (See Figure 2)
- Forgot to install a disc
- NOTE: If any of the previous situations occur, verify the adjuster arm is still inserted in stud (see Figure 8)

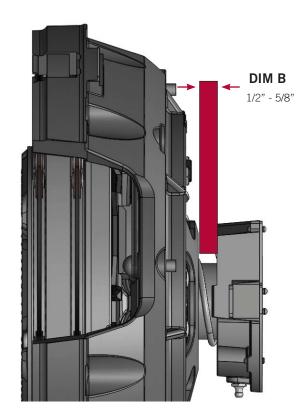
Figure 4

- 6. Remove caging fork from under the release bearing. Remove alignment shaft. Verify bearing distance from cover is 1/2" 5/8" (See Figure 4). **NOTE: Anytime the clutch is removed from the flywheel, the caging fork needs to be reinstalled. Failure to do so will cause adjusting arm to fall out of retainer stud. See Figure 8 in Reset Procedure.**

Check for proper clutch brake and bearing gap of 1/2" to 9/16". If the gap is too small verify DIM B (Figure 4 or Figure 6). If DIM B is correct and a fiber spacer or oversized clutch brake was installed, remove the fiber spacer and/or replace oversized clutch brake with standard thickness clutch brake. **NOTE:** If the gap is larger than 9/16" and DIM B is correct then one of the following conditions exists. Fiber spacer/over-sized clutch brake was not installed or input shaft length needs to be re-measured as seen in Figure 4. DO NOT ADJUST THE CLUTCH!

- Verify bearing position is in spec between 1/2" 5/8" (See Figure 4)
- Input shaft measurement is too long/excessive wear on transmission input bearing retainer (See Figure 5)
- Did not use oversized clutch brake or fiber spacer
- Self-adjust mechanism not working See Reset Procedure

- Verify bearing position is in spec between 1/2" 5/8" (See Figure 4)
- Used oversized clutch brake instead of standard clutch brake
- Have fiber spacer and don't need it

- Verify bearing position is in spec between 1/2" 5/8" (See Figure 4)
- Verify bearing to brake gap is in spec between 1/2" 9/16" (See Figure 6)
- Release system linkage components are worn and need to be adjusted or replaced (See Figure 5)

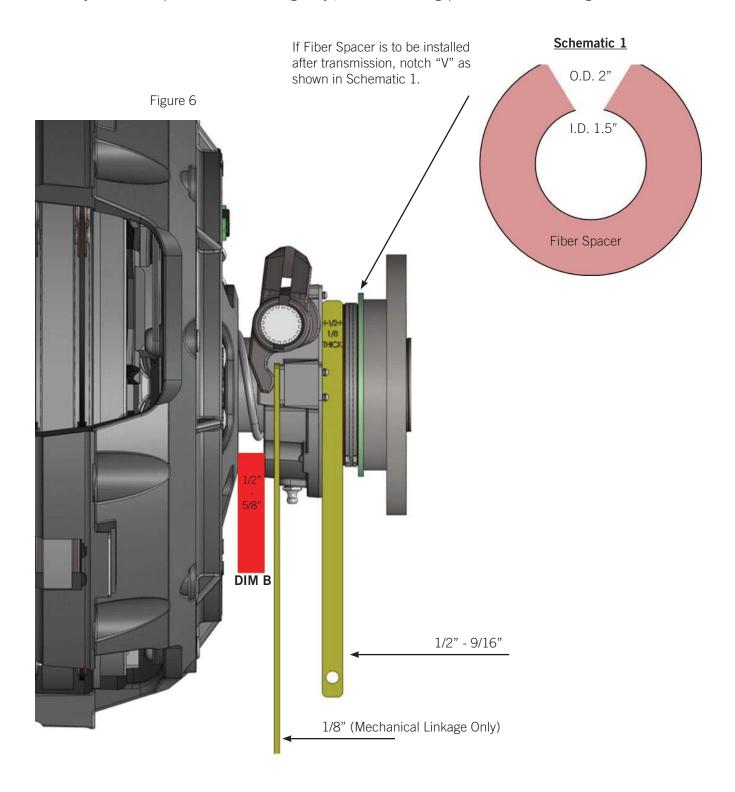
After transmission installation, check the clearance between the yoke tips and wear pads on bearing housing for 1/8" clearance. This determines pedal freeplay (Mechanical Linkage Only). (See Figure 6)

Installer should carefully verify that there is 1/2" - 5/8" gap between clutch cover and release bearing, 1/8" of free travel between yolk and wear pads (mechanical linkage only), and 1/2" - 9/16" gap between release bearing and clutch brake.

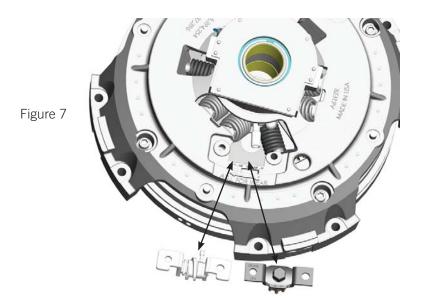
Figure 8

- 1. Remove self-adjusting mechanism. (Figure 7)
- 2. Disengage clutch.
- 3. Install manual adjust mechanism. (Figure 8)
- 4. Manually adjust clutch to meet specs in set-up procedure. (See Figure 6)
- 5. Reinstall self-adjusting mechanism. Ensure adjusting arm is properly seated in the retainer stud as seen in Figure 8.
- 6. When reinstalling self-adjusting mechanism it may be necessary to manually ratchet the self-adjust mechanism so that the worm gear is seated properly in the adjusting ring teeth.
