PLATINUMSHIELD® III COATING CONQUERS RUST-JACKING – AND THE COMPETITION

PLATINUMSHIELD® III COATING CRUSHES THE COMPETITION.

Brake Shoe Coating Performance Testing Results.

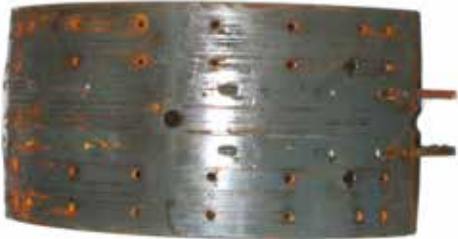
BRAKE SHOE TESTED*	RUST GRADE RATING	SHOES
Meritor PlatinumShield III	9

All tests were conducted from December 2017 through January 2018. Shoes are shown after thermal cycling and torque load conditioning by Meritor. Friction lining removed from brake shoe after conditioning and before salt spray testing. A third party administered salt spray testing per ASTM B-117 for 400 hours and evaluated the rust grade using the scale set forth in ASTM D610-08 (2012).

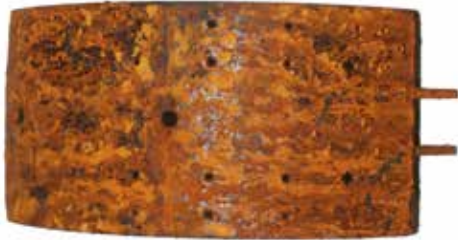
Bendix PermaGuard	1

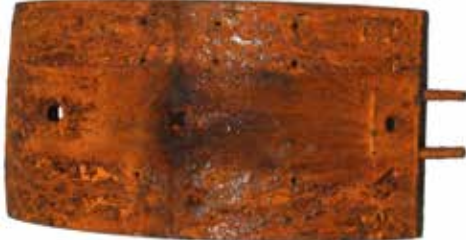
Gorilla Tuff Coat	1

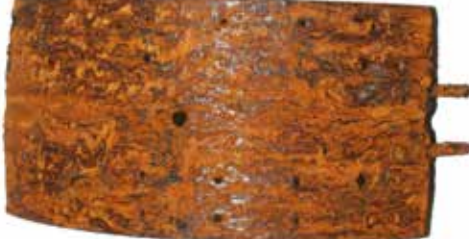
Neobrake	1

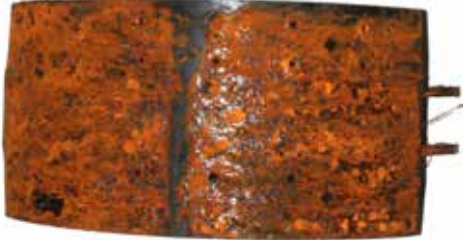
Silverback HD	1
